Process Safety Forum

Process Safety Alert 005

Storage and Handling of Self-Reactive, Energetic Substances

Tank floor failure in 2-Ethylhexylnitrate service.

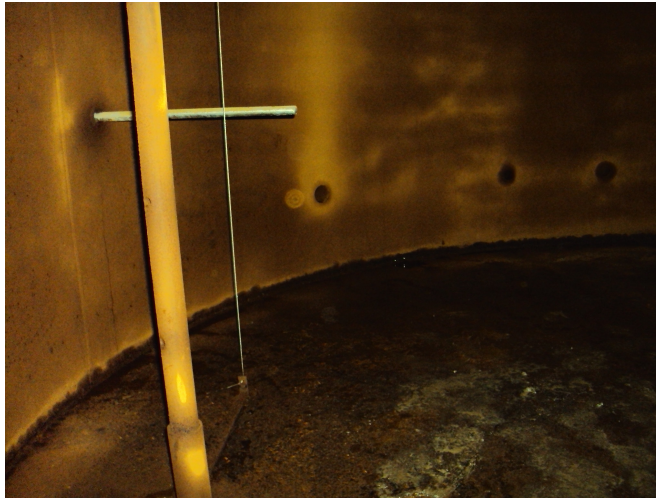
The tank failure occurred due to internal corrosion of the floor and lower wall resulting in a hole of approximately 10mm.

The floor and wall of the tank was uncoated carbon steel and had been inspected in the last 10 years. No pH checks were carried out as part of this inspection. The inspection concluded that the tank was in good condition.

The tank had no water draw sump but a downturned suction nozzle.

Following the failure, inspection revealed that a small amount of moisture had accumulated on the tank floor due to normal tank inbreathing/outbreathing. It is likely that in the presence of water the product can hydrolyse to nitric acid, thus causing the corrosion.

Consideration should be given to the storage and handling of self-reactive, energetic substances.

- When performing Hazardous Operations (Hazop) Analysis, this should assume that water may always be present (even in small quantities), unless special measures have been taken to remove the water content.
- Where appropriate, inspection frequencies should be reviewed and evidence of the ingress of water should be considered as part of the inspection process.
